The
San Francisco Earthquake and Fire

A BRIEF HISTORY OF THE DISASTER

A Presentation of Facts and Resulting Phenomena, with Special
Reference to the Efficiency of Building Materials
Lessons of the Disaster

A. L. A. HIMMELWRIGHT, C.E.

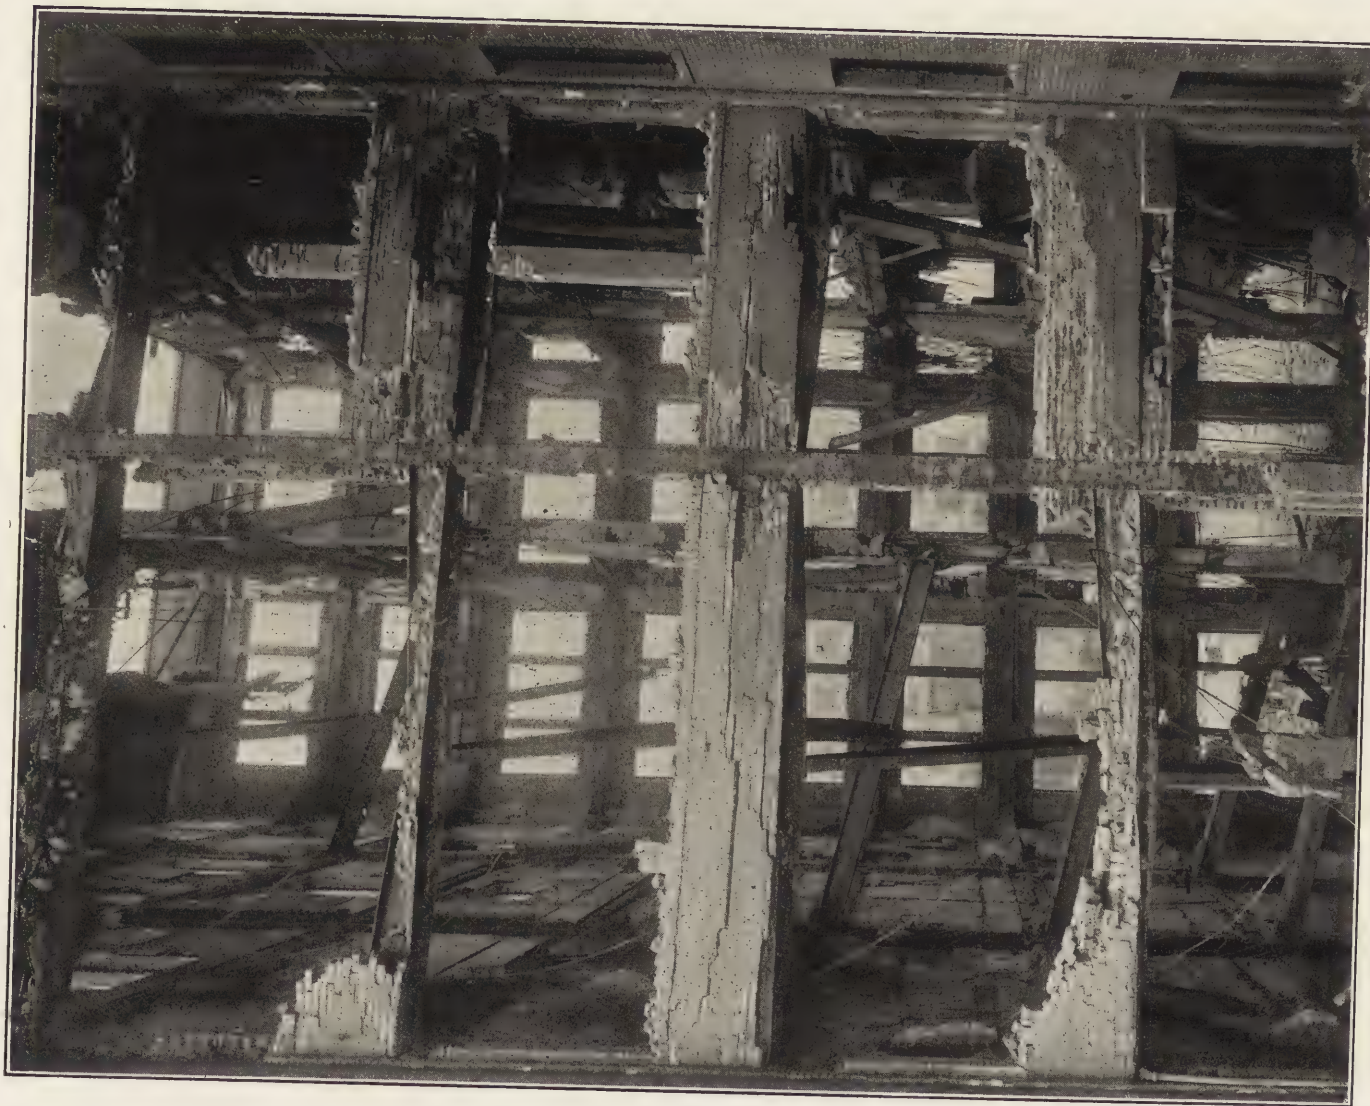
RIALTO BUILDING. Looking across the light court from one wing of the building toward the other wing, the interior of which was wrecked by buckling columns in the basement. The strength and tenacity of the steel connections are noteworthy. The beams connected to the wall girders midway between columns frequently twisted the girder through an angle of 75° . Some of the concrete floor slabs are still hanging in vertical positions at the sides.

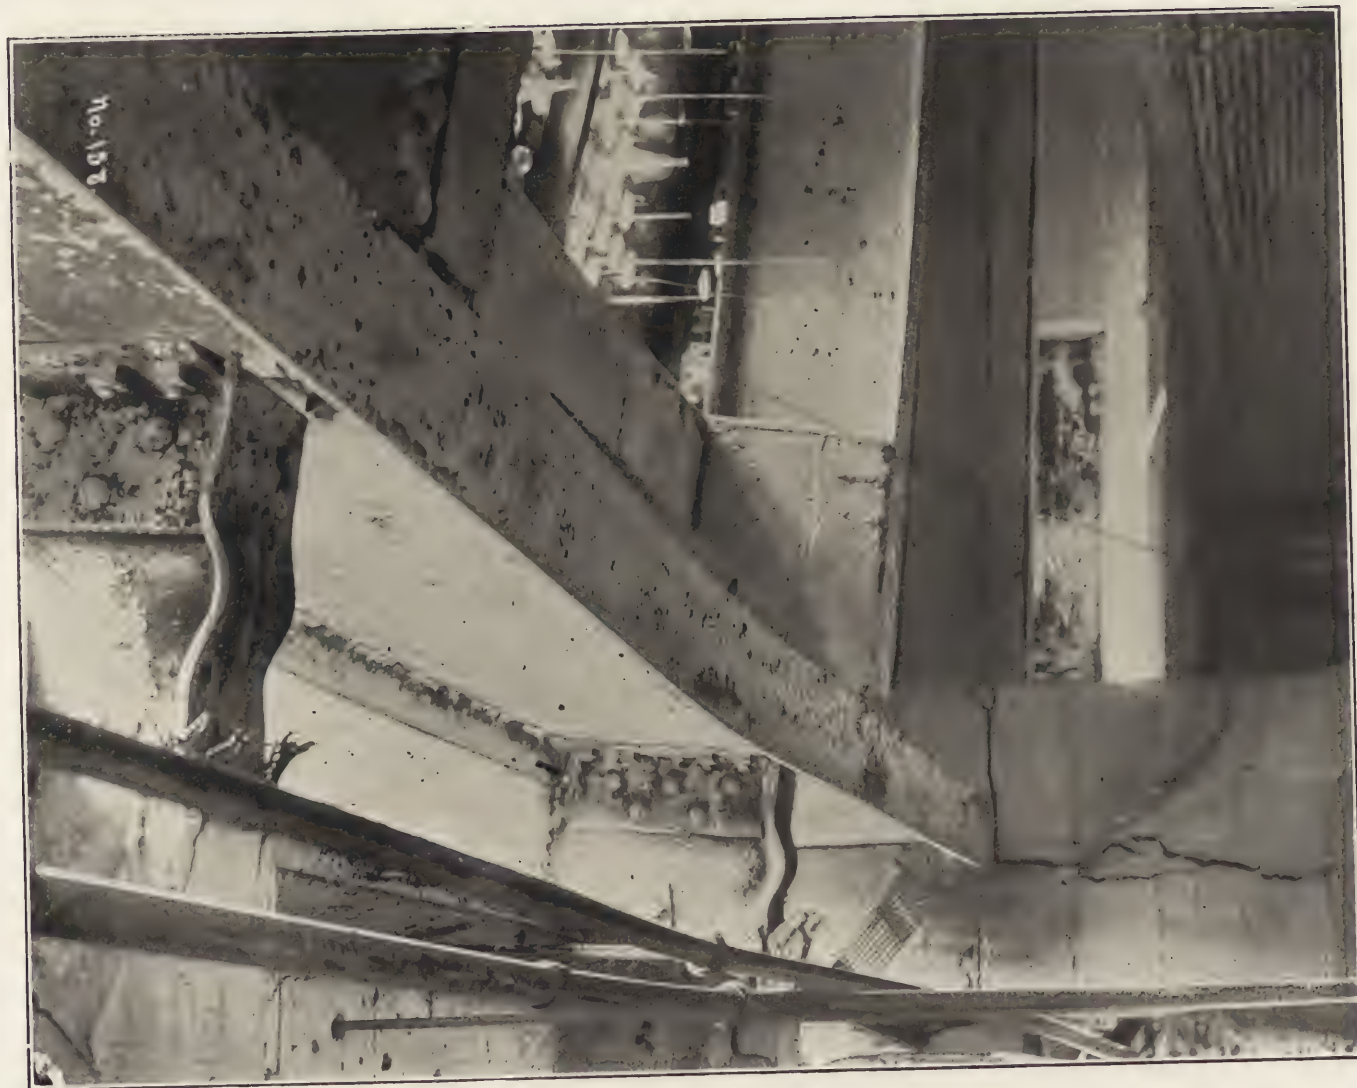
RIALTO BUILDING. Basement Story. Showing the unprotected steel at the building line where the vents were carried up underneath the first story show windows from the basement. The glass prisms of the sidewalk lights fused, the glass hanging in shreds as shown. Note also the earthquake damage to the supporting concrete pier. Compare this with the illustration on the opposite page.

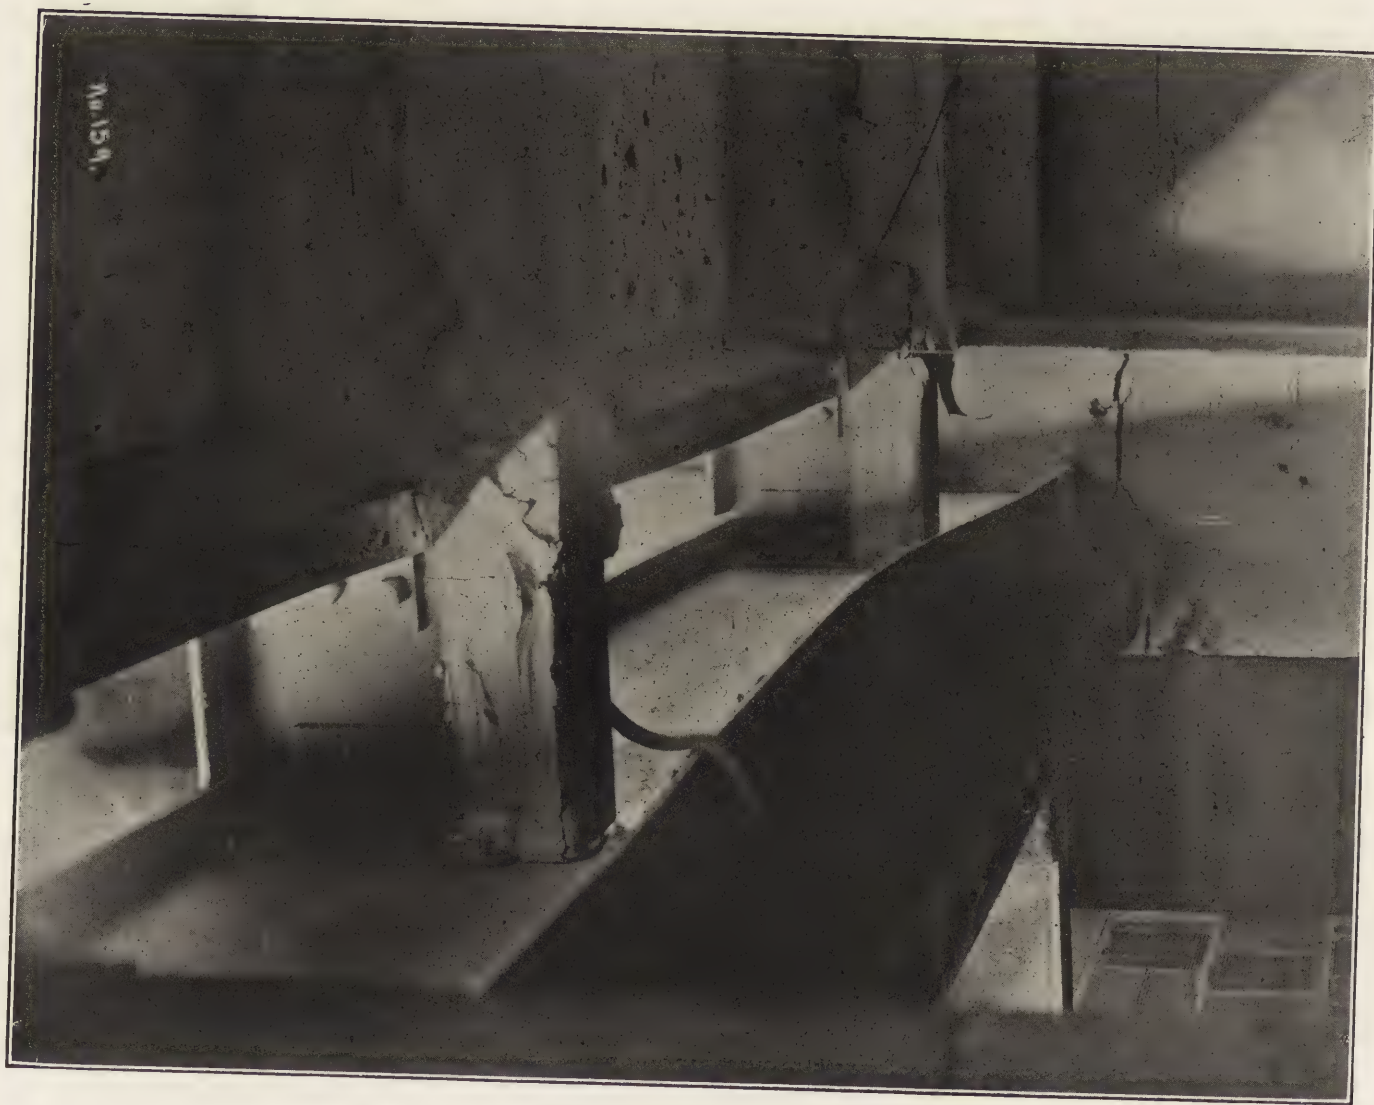
RIALTO BUILDING. Basement Story. Showing the adjoining bay of unprotected steel at the building line, but with the floor beams partially fire-proofed with concrete. This small amount of protection prevented the floor beams from buckling, and caused the unprotected girder to deflect instead. Compare this with the illustration on the opposite page. Vents of this character are extremely bad practice from a fire-proofing standpoint, and when employed, the structural steel should be very carefully protected.

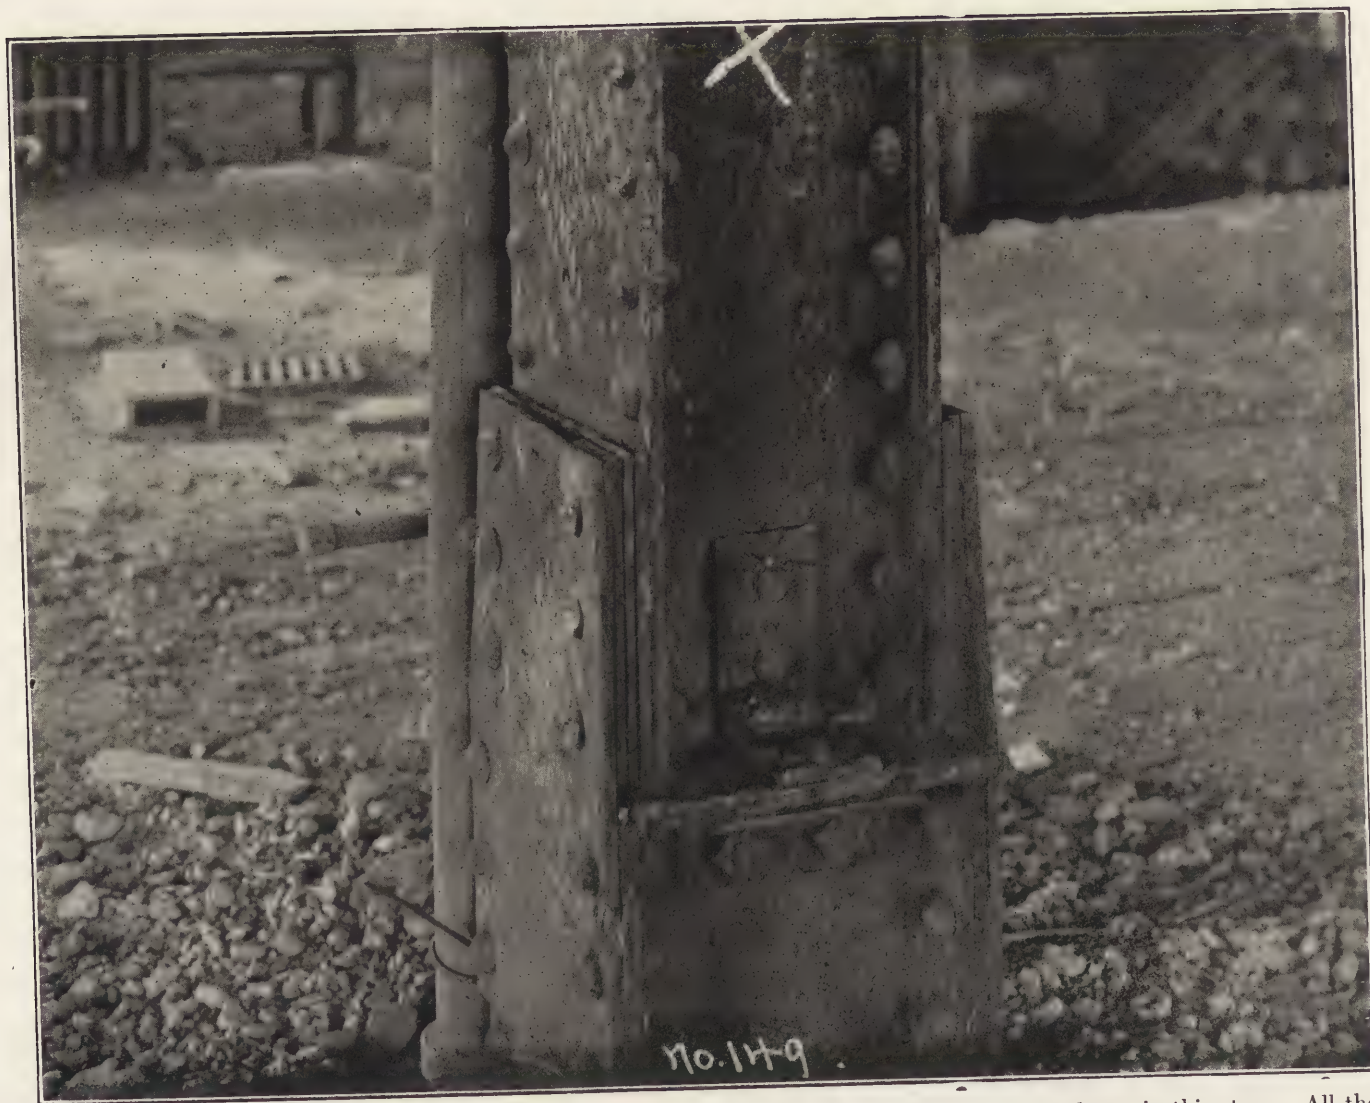
RIALTO BUILDING. Fourth Story. Showing splice and connections of a typical column in this story. All the columns in the building change from a larger to a smaller section at this level, producing a structural weakness which caused characteristic X cracks in all the piers between the windows in the fourth and fifth stories.

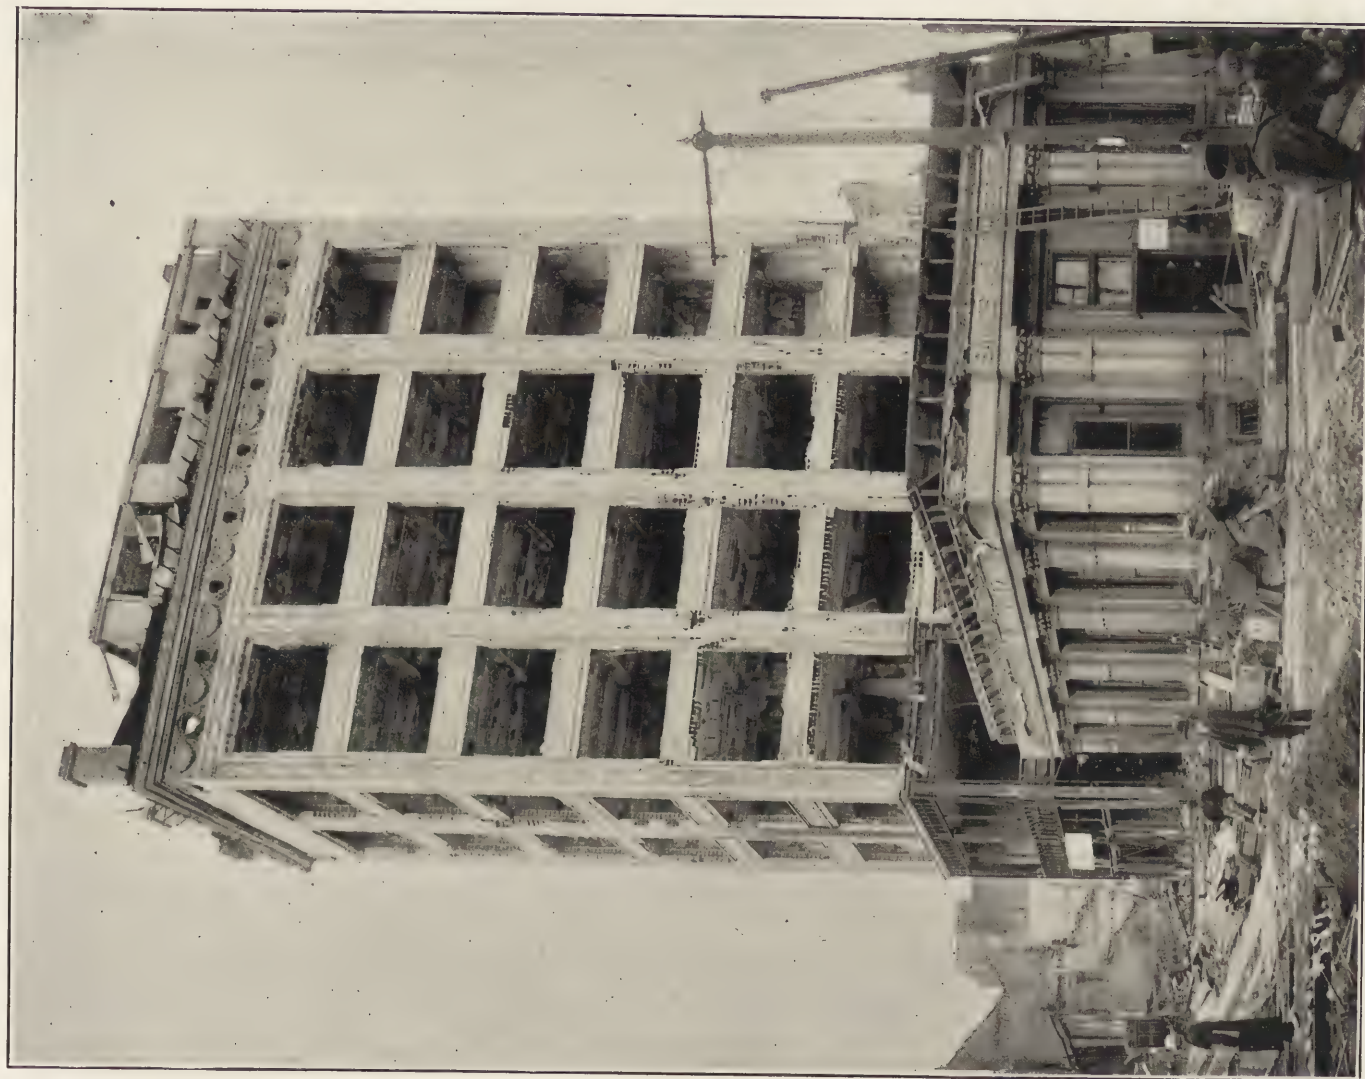
BULLOCK AND JONES BUILDING. North side of Sutter Street, between Montgomery and Kearny Streets. The façades consisting of cream terra cotta and glass for the first two stories and pressed terra cotta brick, with terra cotta ornamentation above, are badly damaged, and the metal cornice is wrecked. Two columns are buckled in the third story near the middle of the building on account of the failure of the 3" hollow tile protection. The steel beams around the stairway and elevator walls were unprotected and bulged inward. The expanded metal concrete floors are in good condition. The hollow expanded metal lath and plaster inclosures of the elevator shaft and stairway are badly deflected, but remain standing. The hollow tile column protection is ruptured in many places, and a large proportion of it has fallen away. Bulging pipes, as usual, have contributed to this damage.

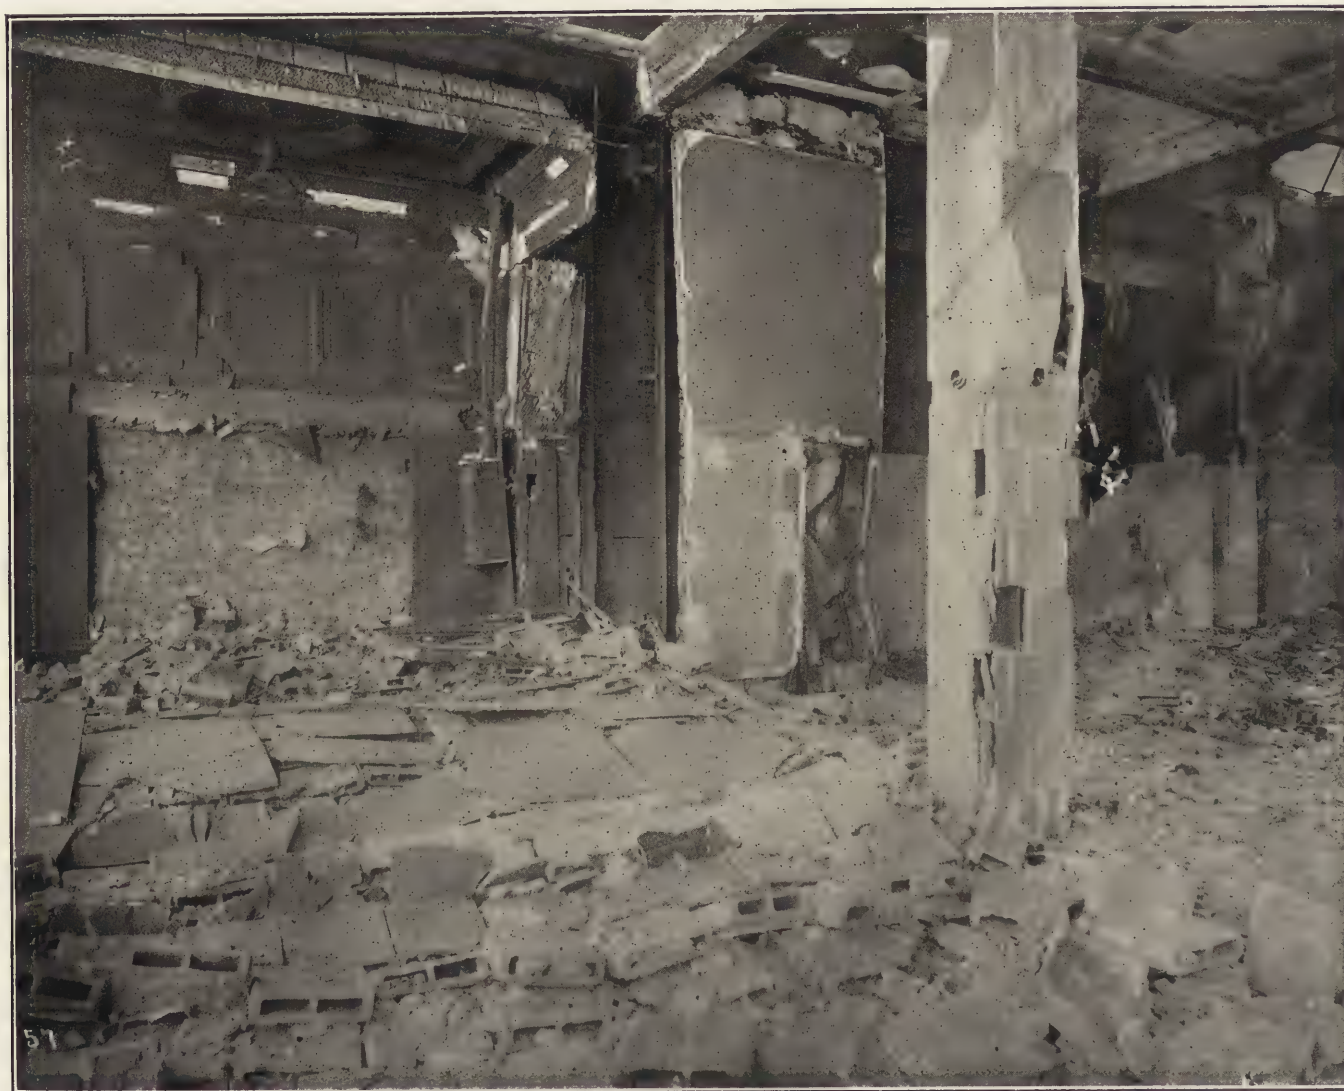
BULLOCK & JONES BUILDING. First Story. Showing the condition of the expanded metal concrete floors, and the hollow tile partitions and column covering. The expanded metal lath and plaster partition around the elevator shaft is standing, but has deflected out of plumb. The Cutler mail chute is bulged on account of the expansion due to the heat. The opening through the second floor at the upper right hand is the same shown in the succeeding illustration.

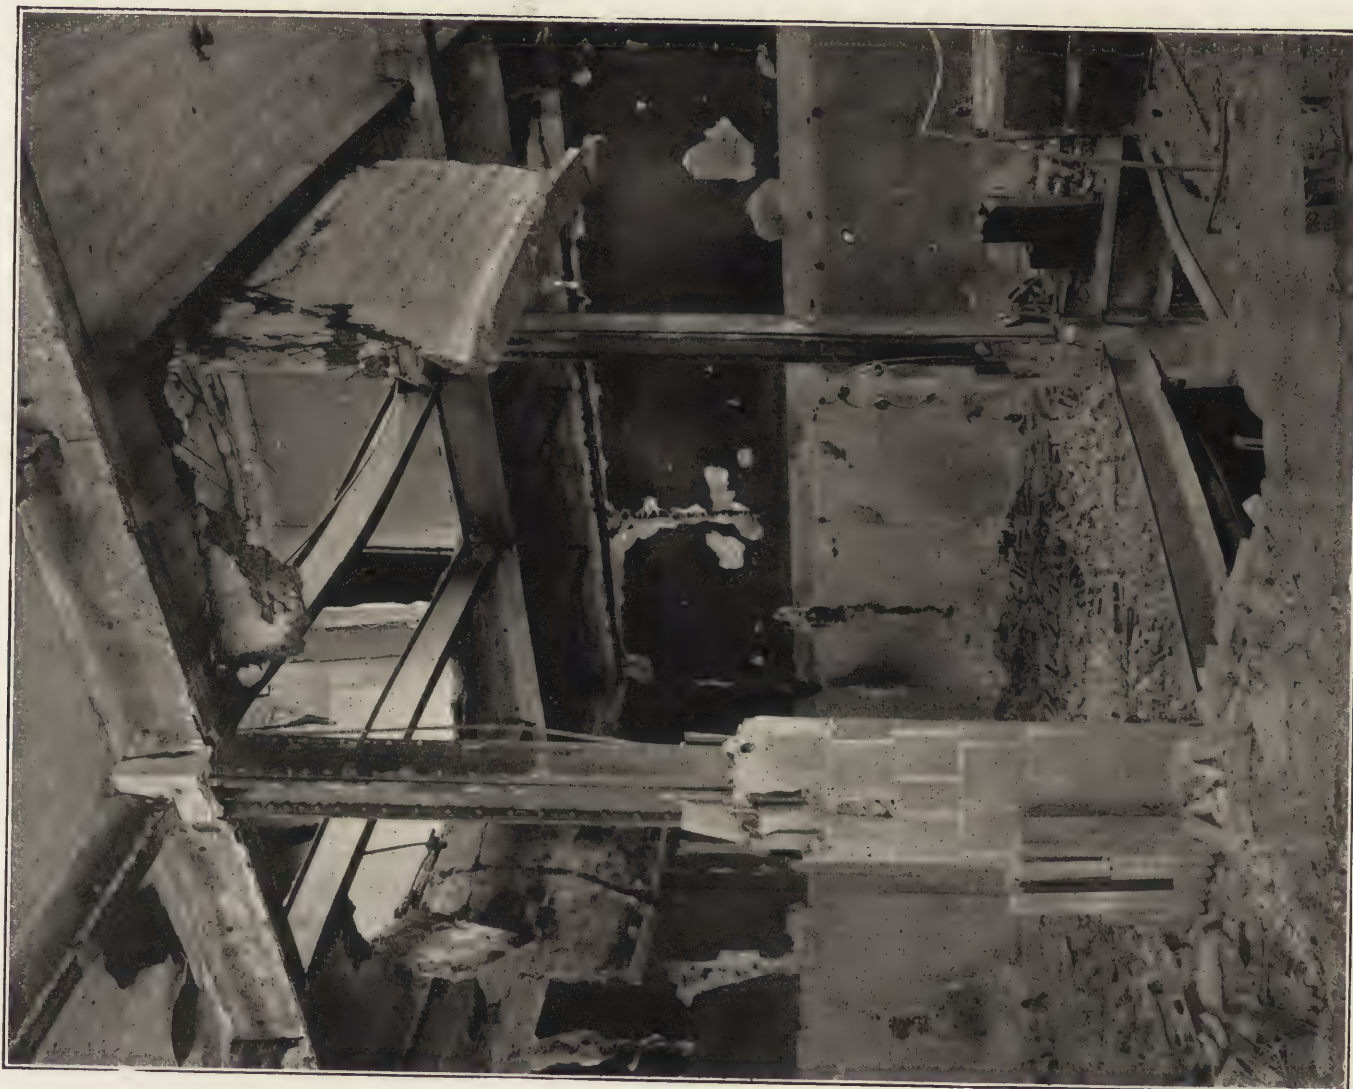
BULLOCK & JONES BUILDING. First Story. Showing the bulged and warped steel framing around the stairway openings in the first and second floors. The steel beams in the ceiling of the second floor bulged inward toward the opening, removing the support of the two adjoining arches, allowing them to drop down into a vertical position supported by the beams on the opposite sides. Note the settling of the floor slab on the right hand side of the opening on the first floor, and the bulging of the beam which originally supported it. The hollow tile column protection failed badly. A wire lath and plaster partition is standing in the rear on the right.

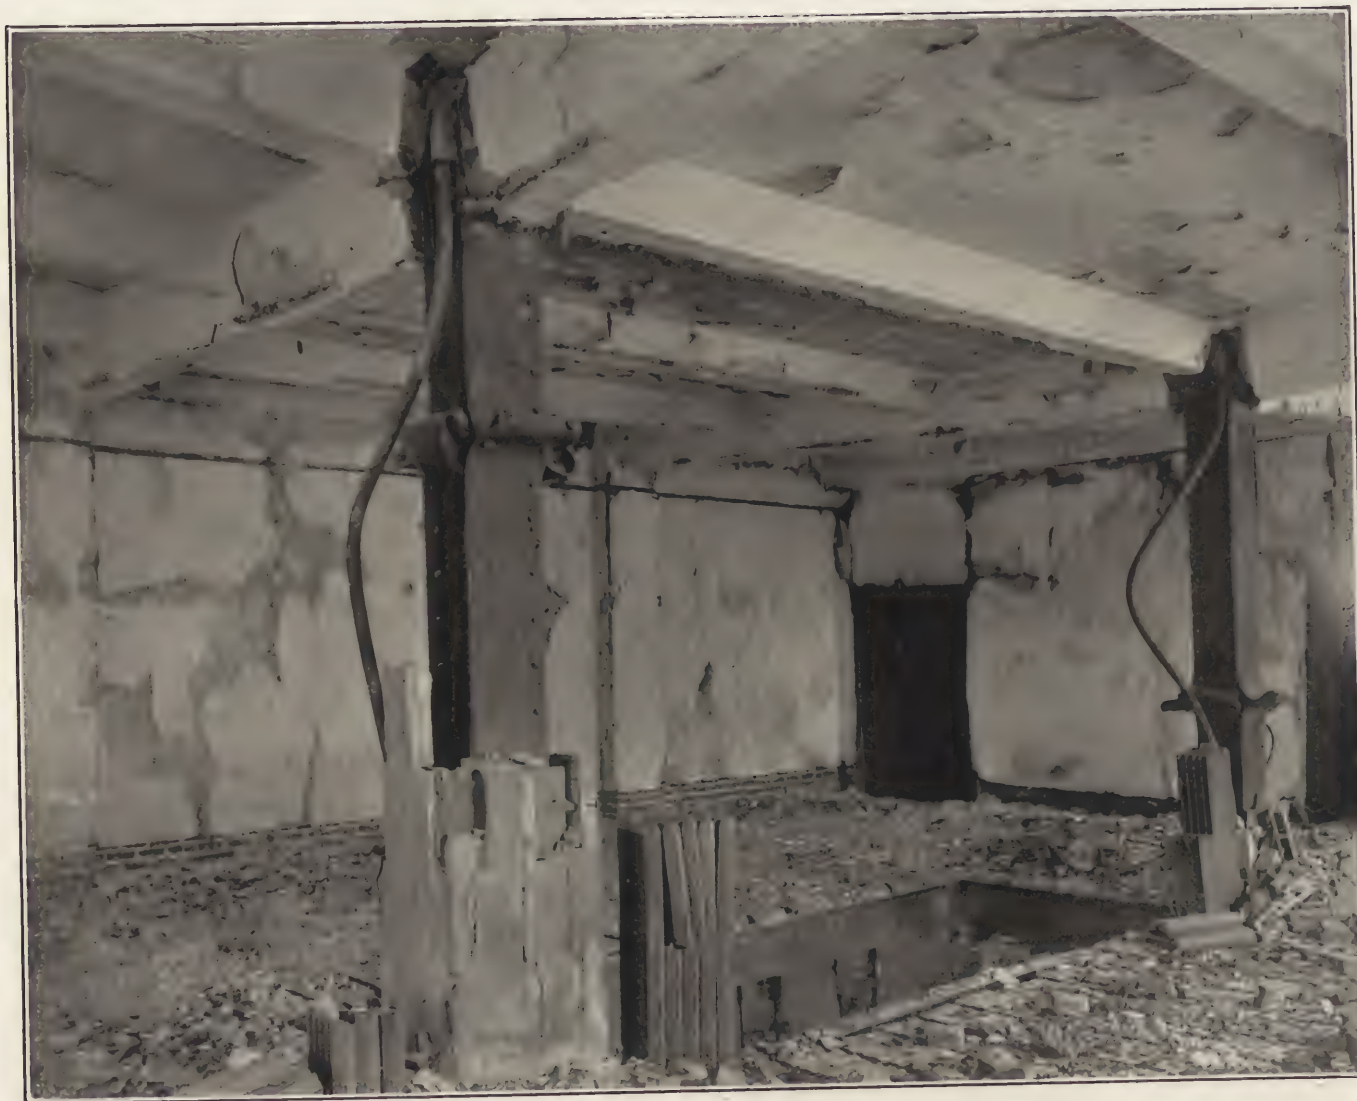
BULLOCK & JONES BUILDING. Third Story. Showing the failure of the hollow tile column protection and the consequent buckling of two columns. The pipes within the column protection no doubt forced it off when they became heated and bulged by expansion. A metal lath and plaster partition remains standing on the right-hand side. The concrete floors are in good condition and in place, notwithstanding the settling of the columns and the distortion of the steel beams and girders. Note also the bulging of the steel beams in the stairway opening, due to unprotected facias.

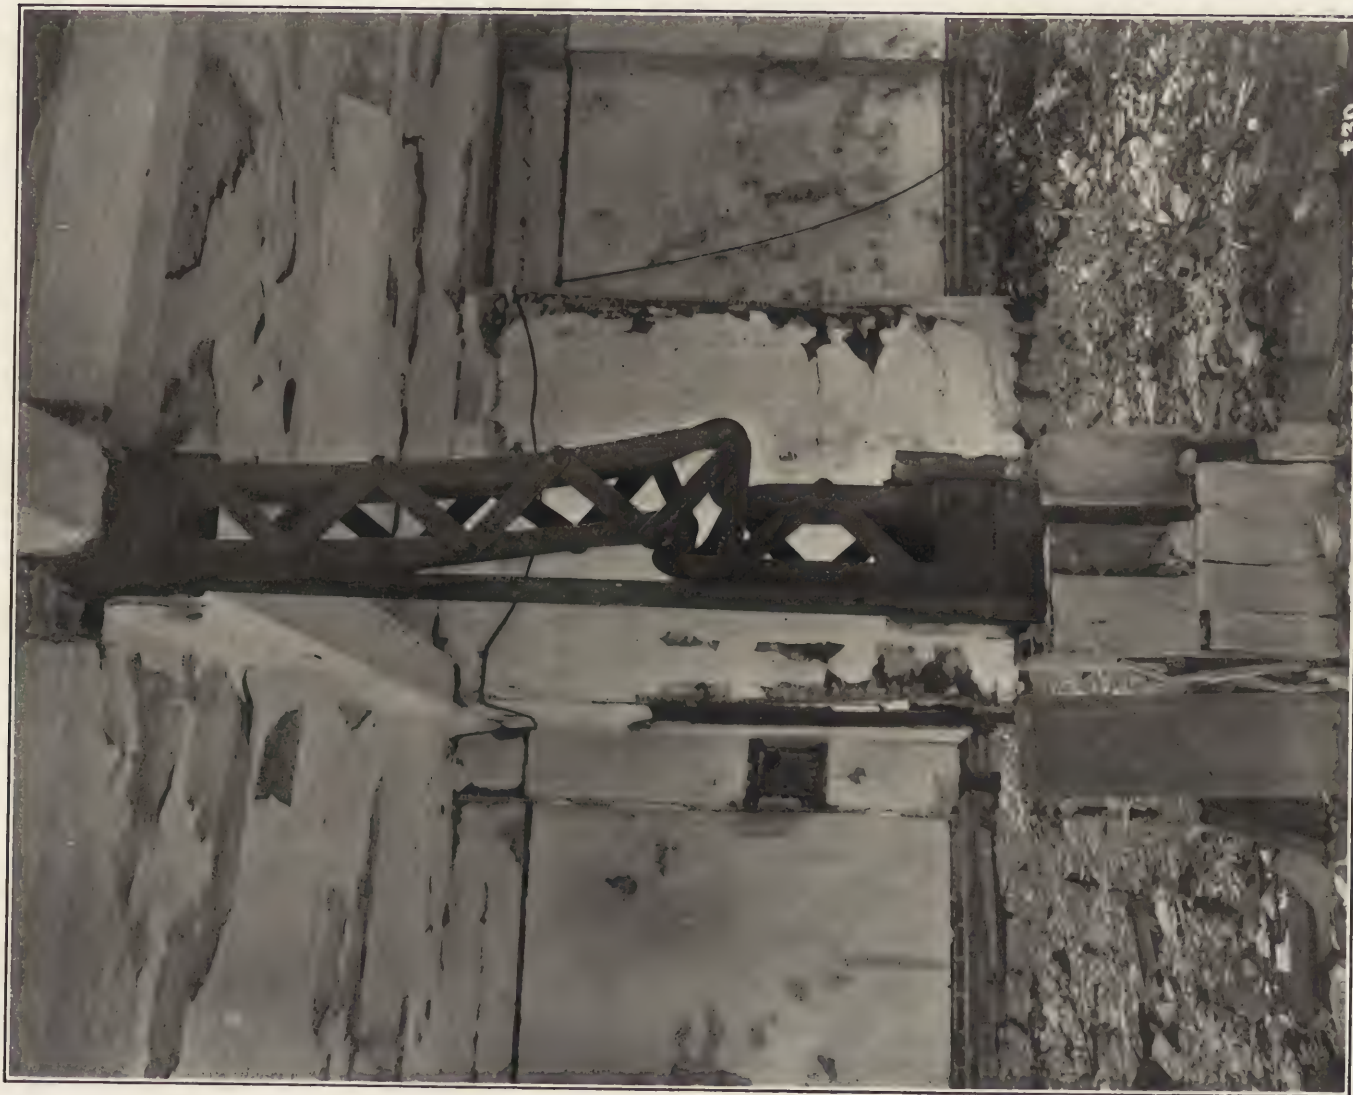
BULLOCK & JONES BUILDING. Eighth Story. Showing the failure of the column protection, and the buckling of the column as a consequence. The corner beads of the shaft enclosure in the rear and of the pilaster around the wall chace expanded and cracked the plaster adjacent to them.

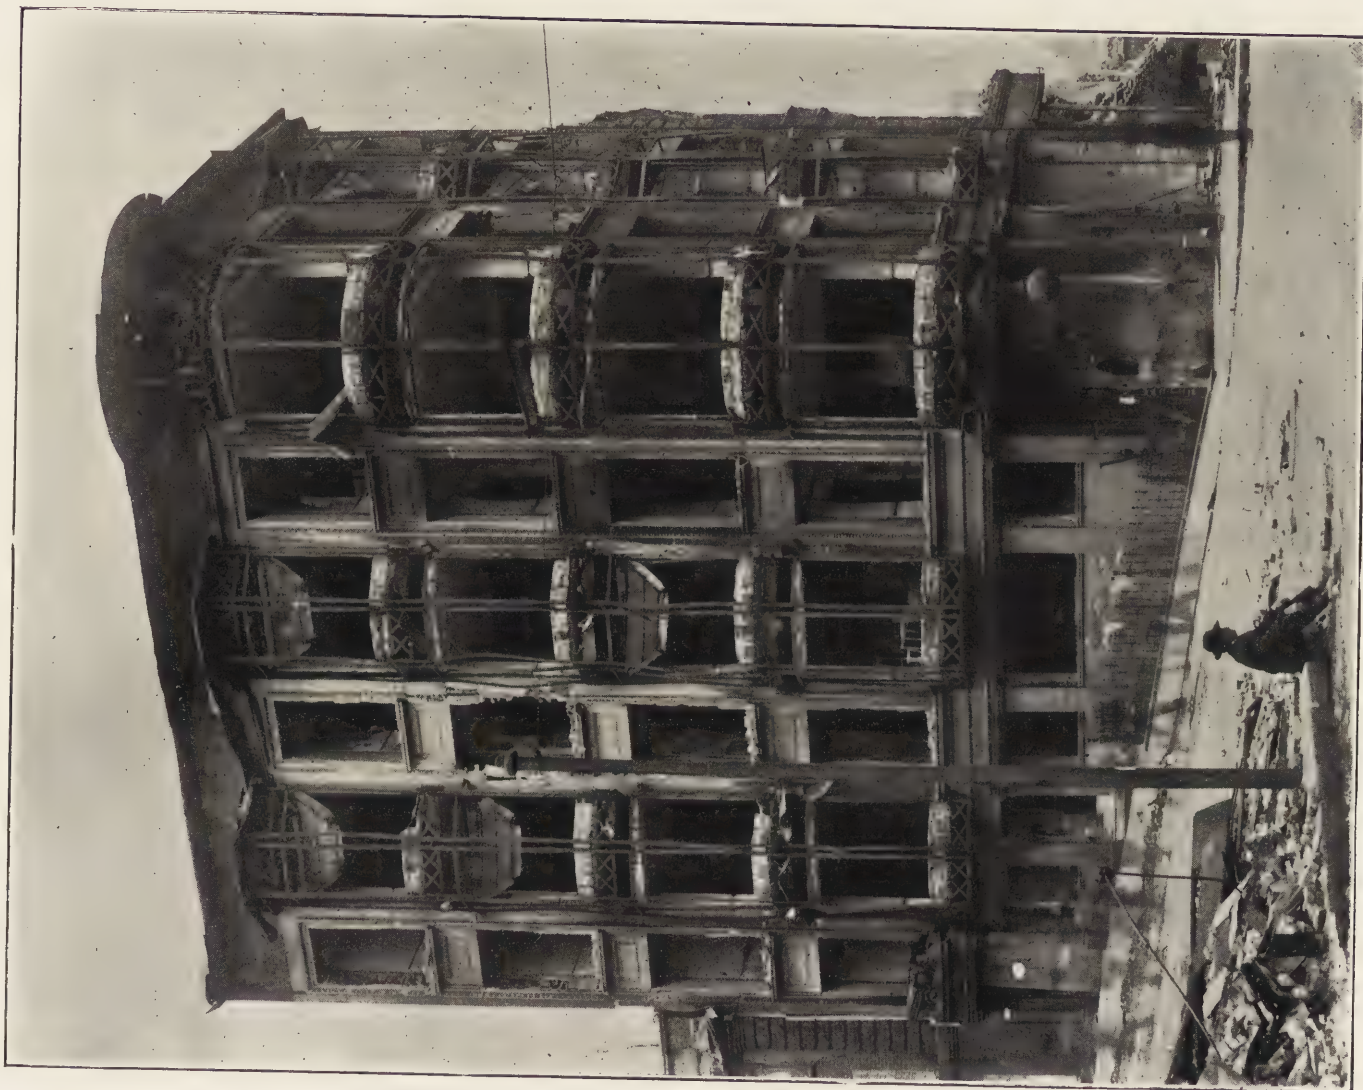
MURPHY BUILDING. Northwest Corner California and Kearny Streets. The burning of the large bay windows which were almost wholly of wood construction and finish, distorted the vertical steel framing. The expanded metal concrete floors and metal lath ceilings are in good condition in this building. The metal lath and plaster partitions are considerably sprung out of plumb.

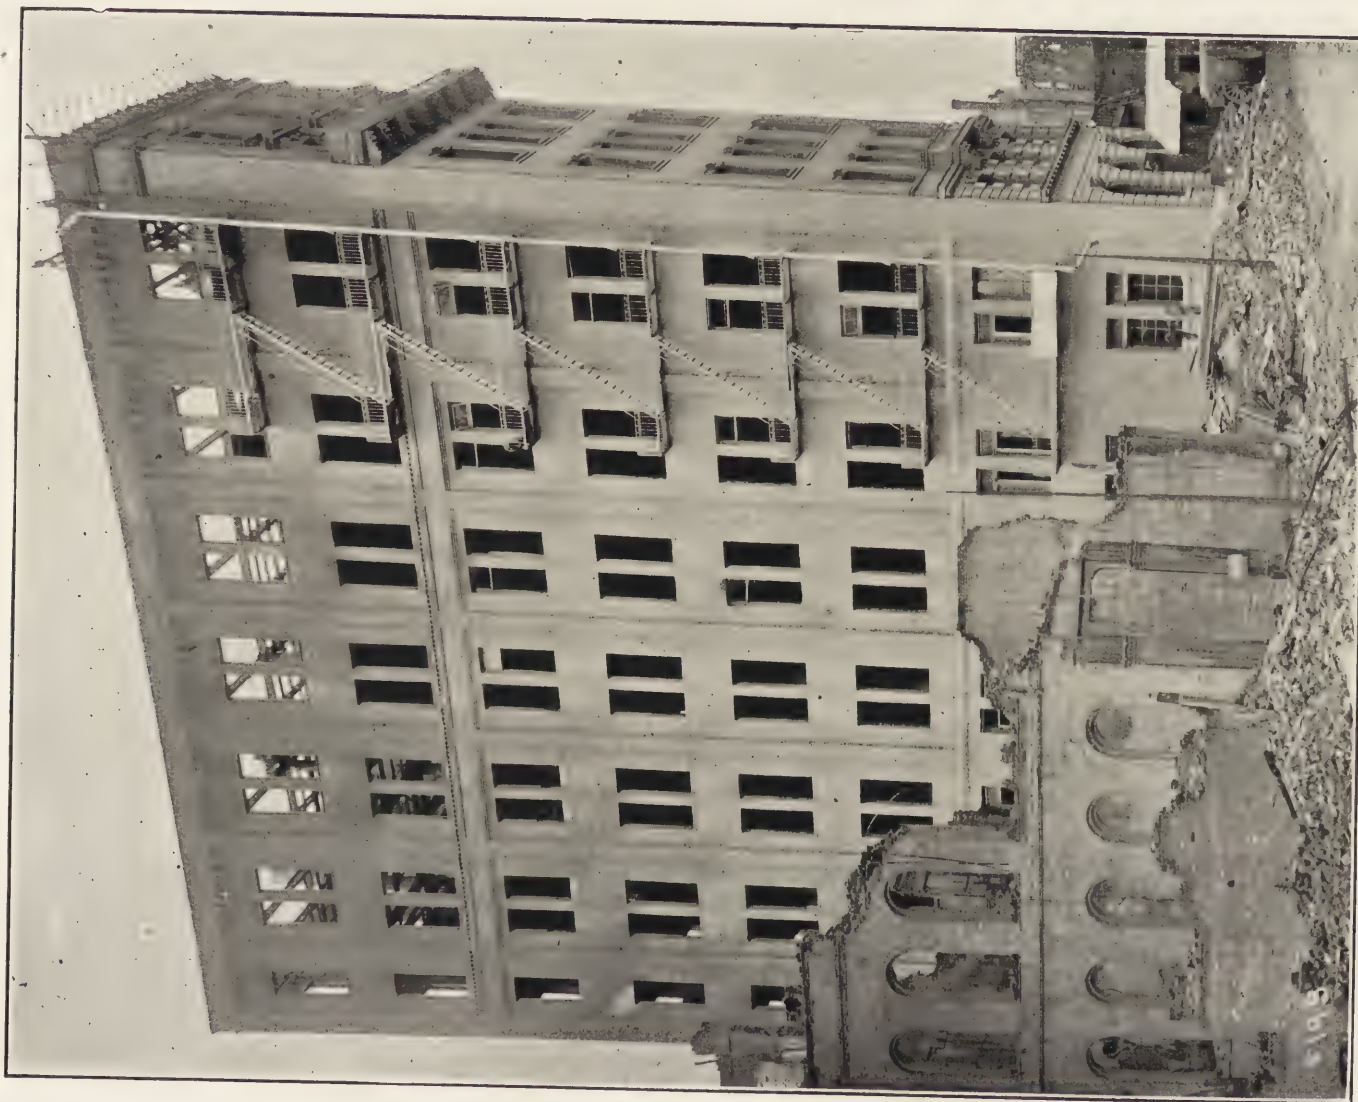
PACIFIC STATES TEL. & TEL. CO.'S Main Office, South Side of Bush Street, between Grant Avenue and Kearny Street. The façade of buff terra cotta pressed brick and terra cotta ornamentation is in good condition, there being only a few slight earthquake cracks at the fifth and sixth story levels. All the window openings of this building were protected by metal and metal-covered inside shutters. The fire entered through the only unprotected door opening in the rear at the first-story level, consuming everything that was combustible within, and rendering the fire-proof barriers that had been provided useless, except to prevent draughts. This building was filled with supplies and equipment, producing an intensely hot fire. The Roebling concrete floors and column protection are uninjured. The Roebling wire lath and plaster ceilings and wall furring are in good condition throughout. The wire lath and plaster partitions have buckled out of plumb in some cases. In the roof tier, reinforced concrete beams were employed between the girders. The fire caused the total failure of one of these, and deflected the rest in this tier so that they required renewal. The photograph was taken after the repairs of the roof tier had been started. The steel work throughout is uninjured.

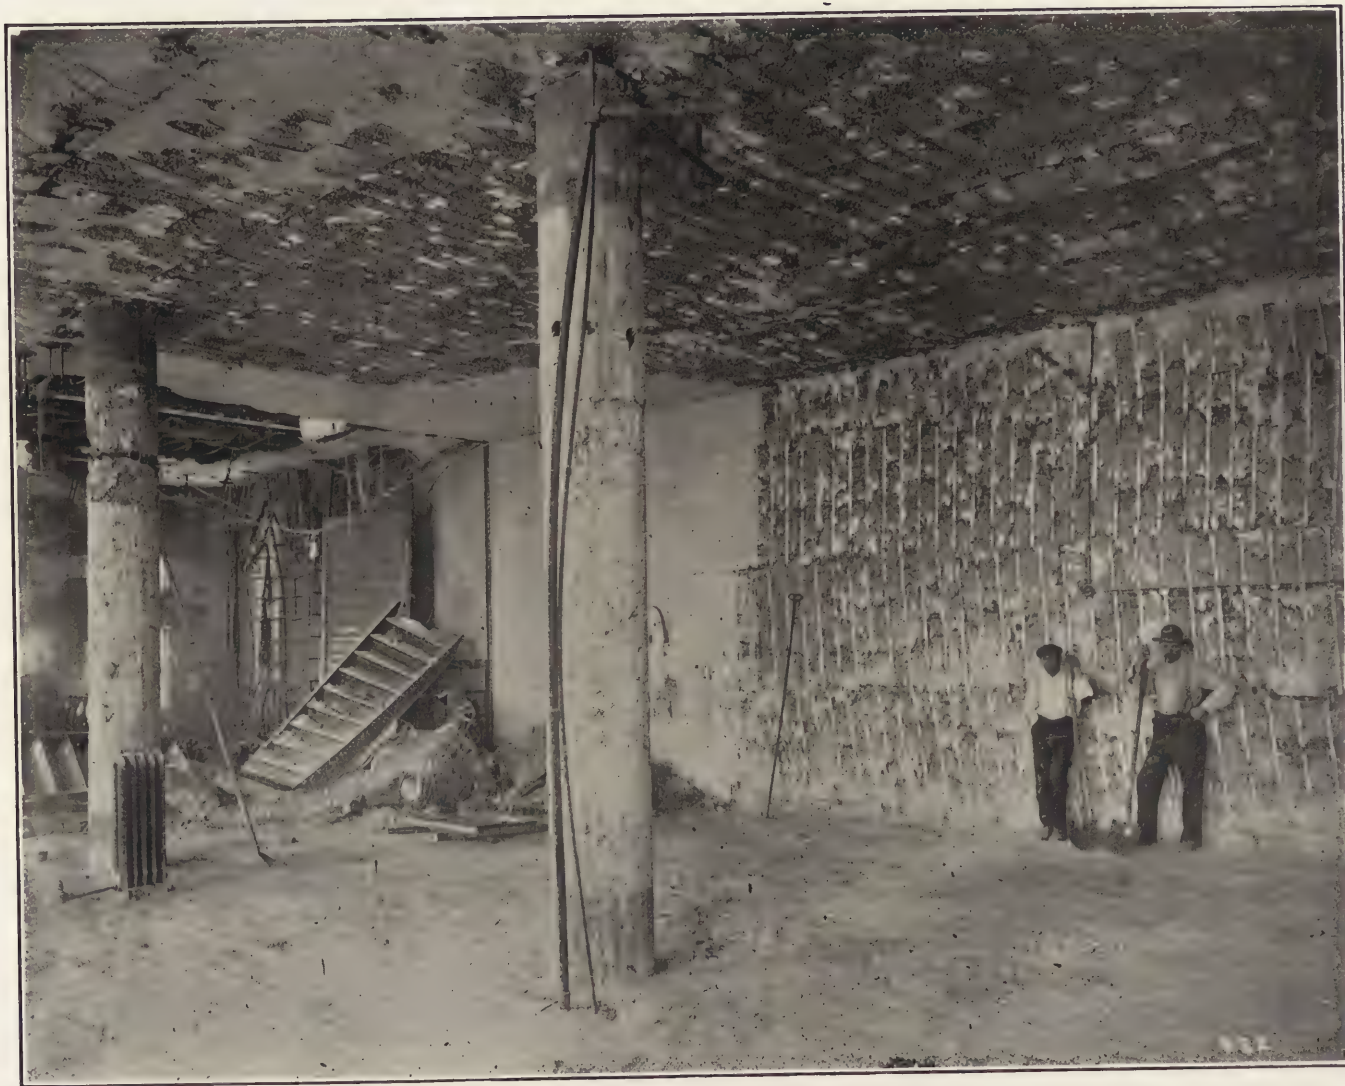
PACIFIC STATES TEL. & TEL. CO.'S Main Office. Fourth Story. Showing the typical condition of the Roebling concrete floors, wire lath and plastered ceilings, wire wall furring and concrete column protection. The photograph was taken after the repair work had started and some of the plaster had been removed. This story was subjected to a severe fire, particularly around the cable rack well in the rear corner. The intense fire at this point spalled the brick wall and caused the failure of the cast-iron and metal tread stairway.

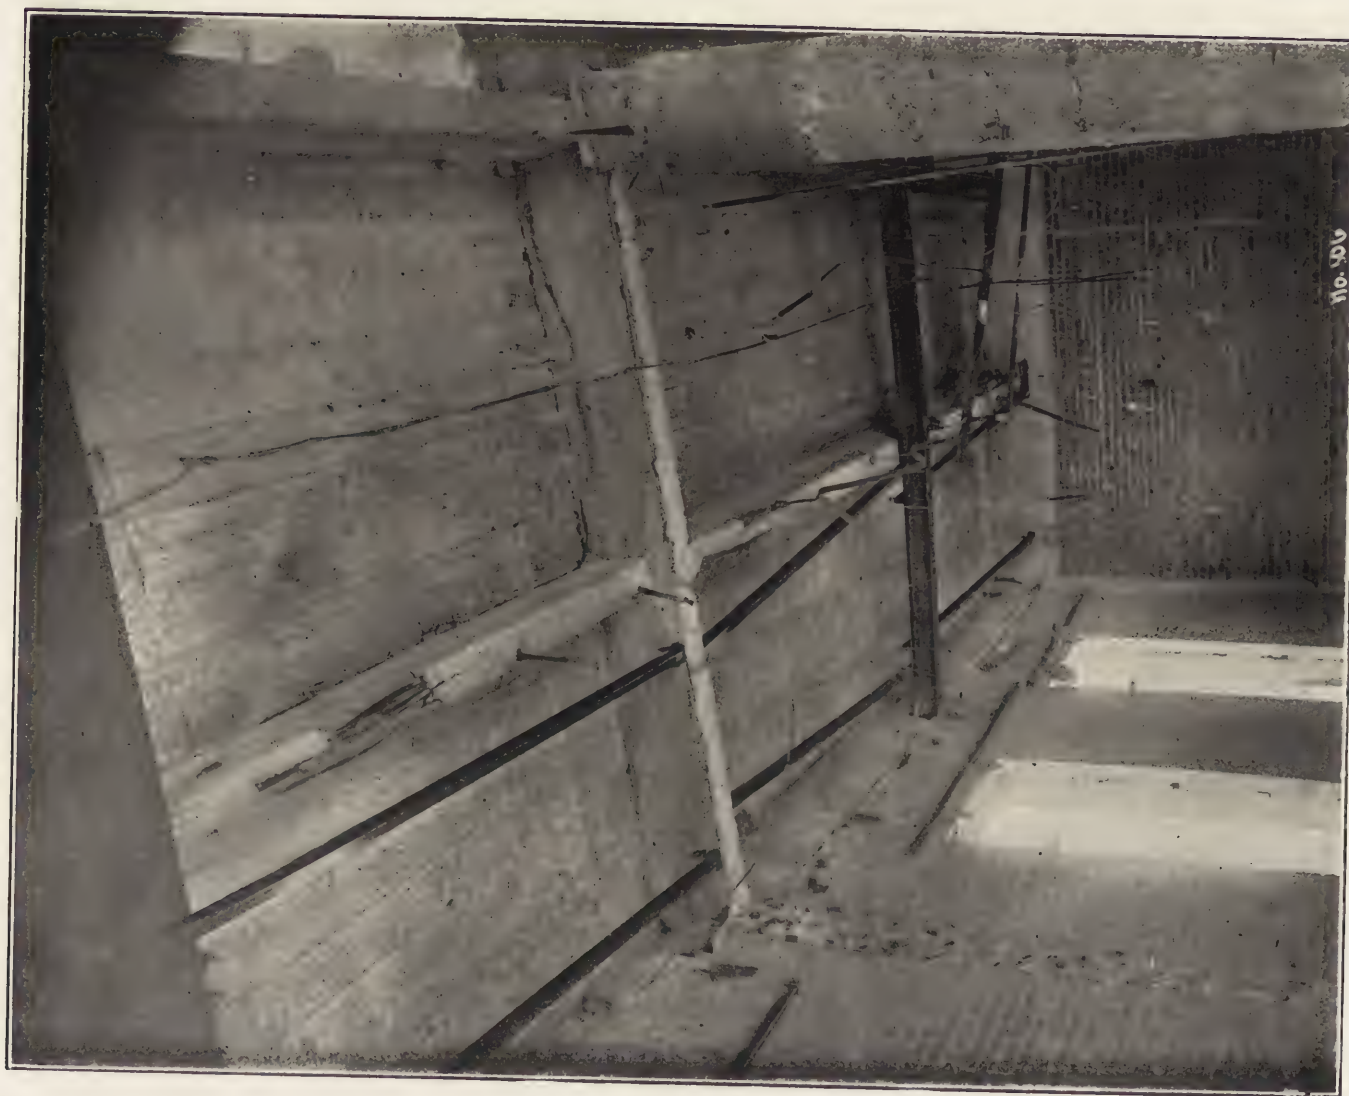
PACIFIC STATES TEL. & TEL. CO.'S Main Office. Showing the partial failure of the reinforced concrete beams supporting the roof, which were damaged by fire. The photograph was taken after the temporary shoring had been put in place.

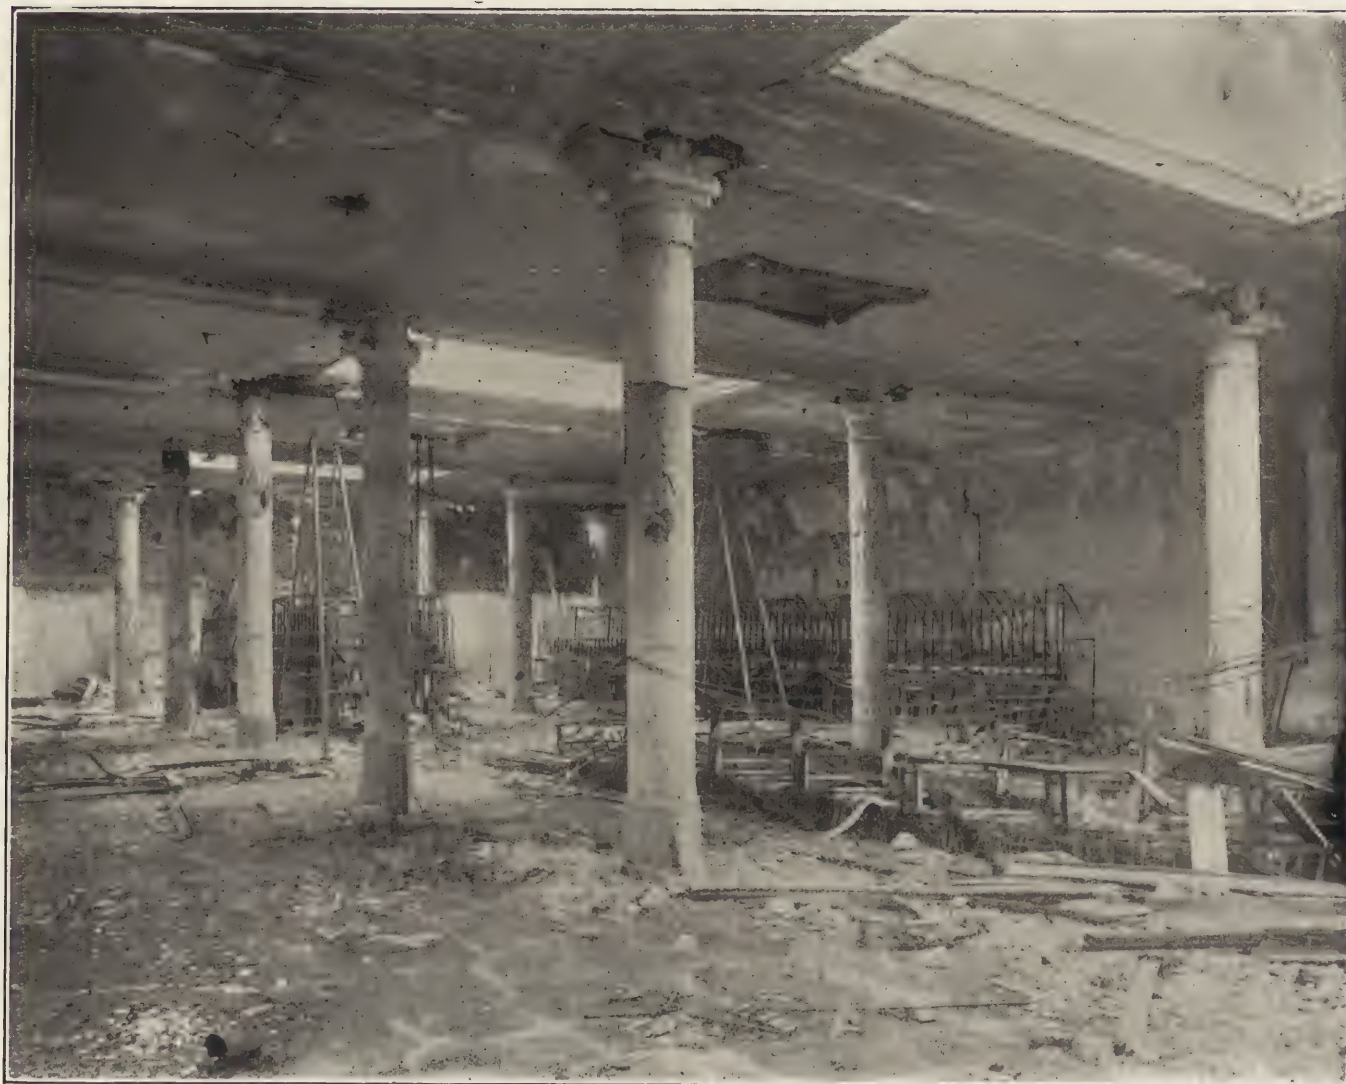
PACIFIC STATES TEL. & TEL. CO.'S South Office. Third Story. Showing the large switchboard, valued at \$90,000, totally destroyed. The Roebling concrete column protection, three large skylights, and the suspended wire lath and plaster ceiling are in good condition. The cement floor finish is but slightly damaged.
